Service Bulletin

15-046

Vibration While Driving and/or Stopped in Gear

Year	Model	Trim	VIN Range
2015	CR-V	ALL	ALL

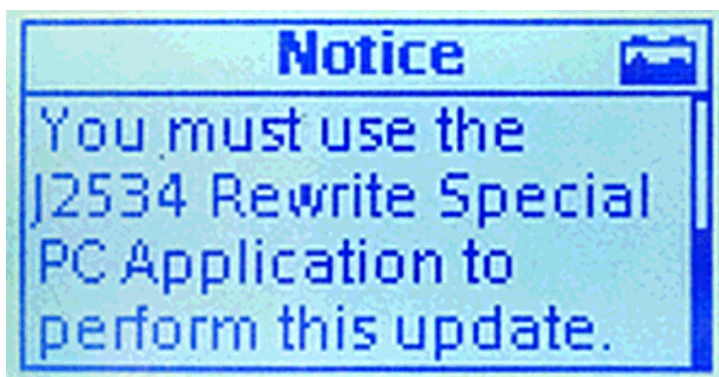
- The control module updates for this bulletin cannot be applied with the MVCI. You must use the J2534 Rewrite Special PC application and MongoosePro Honda. If you try doing the software update using the MVCI, you will see the following screen as shown below.

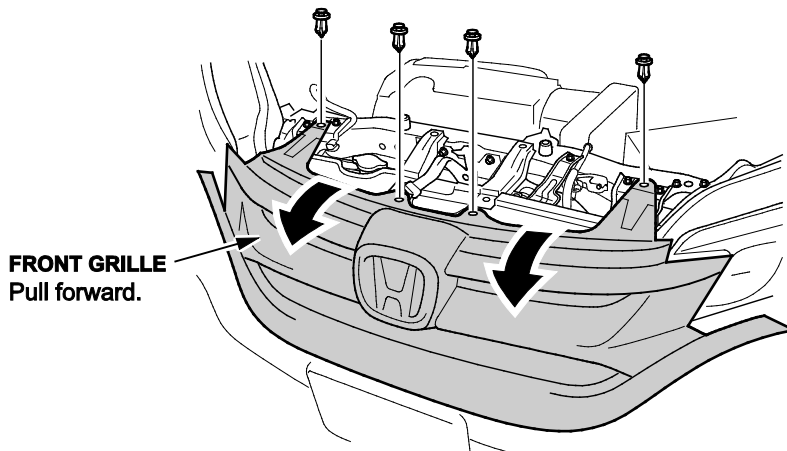
1. Open the hood and remove the four clips that attach the front grill to the bulkhead.

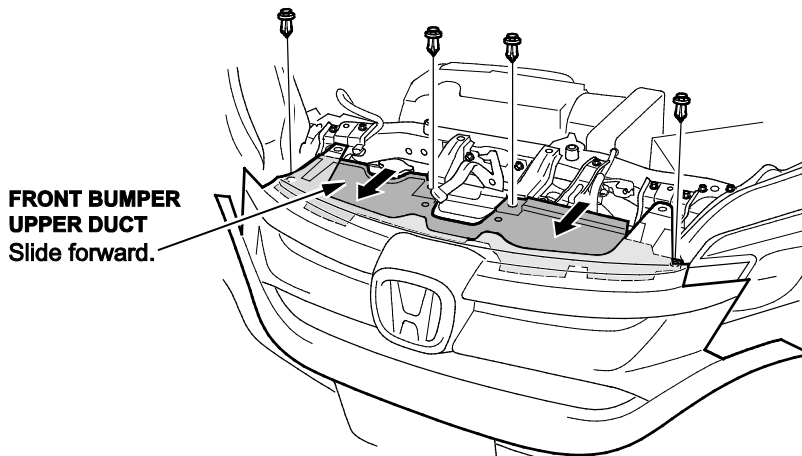
2. Remove the four clips from the front grill and slide the upper duct forward and remove it.

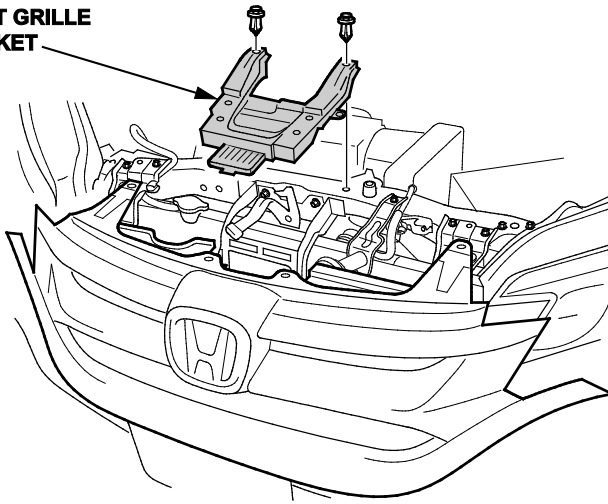
**FRONT GRILLE
BRACKET**

3. Remove the front grille bracket.

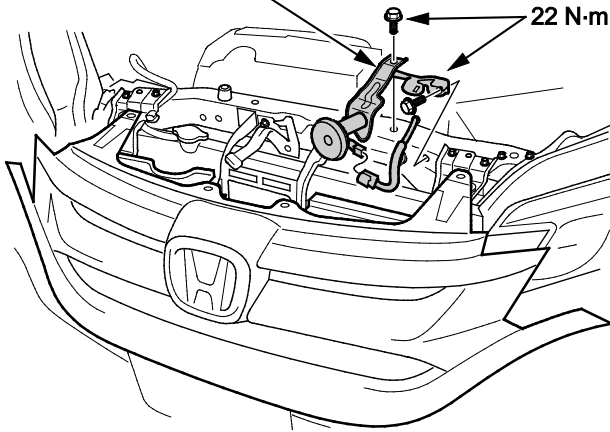
HORN BRACKET ASSEMBLY

4. Remove the horn bracket assembly.

22 N-m (16 lb-ft)

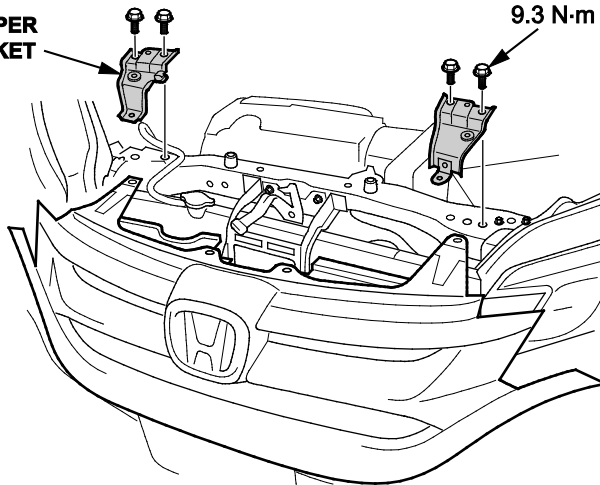
**RADIATOR UPPER
MOUNT BRACKET**

5. Remove radiator upper mount brackets.

9.3 N-m (6.9 lb-ft)

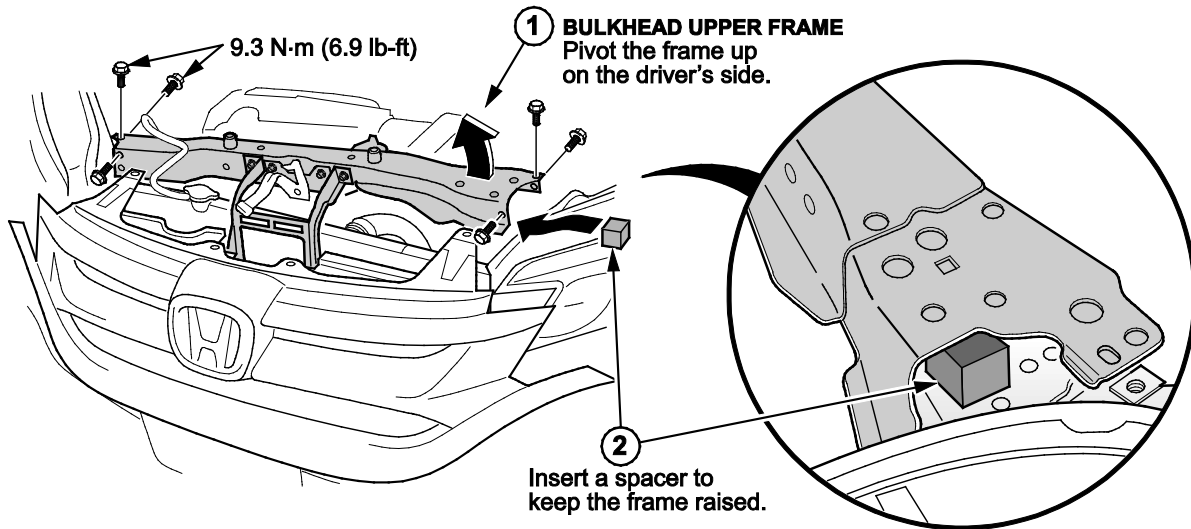
6. Remove the bulkhead upper frame bolts and temporarily insert a spacer on the driver's side of the bulkhead.

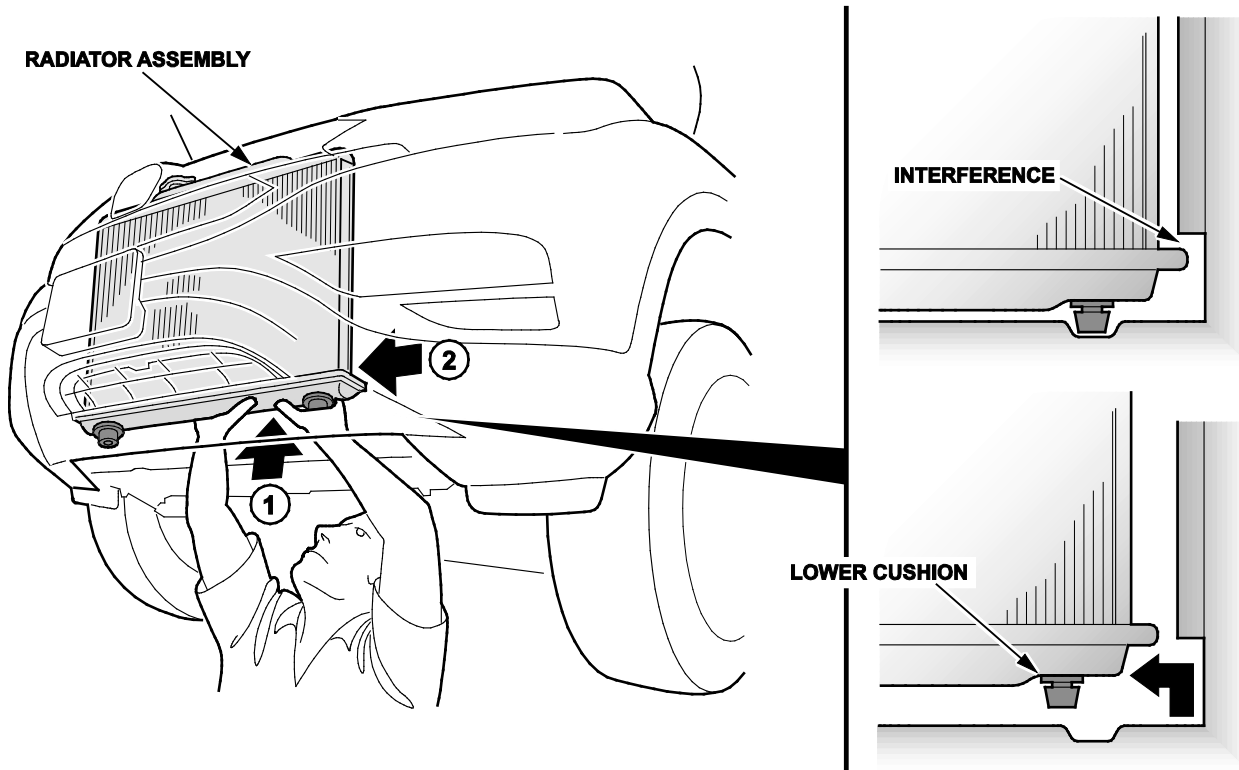
7. Raise the vehicle and remove the lower splash shield. Push the radiator assembly up, then towards the passenger side of the vehicle to gain better access to the lower radiator cushions.

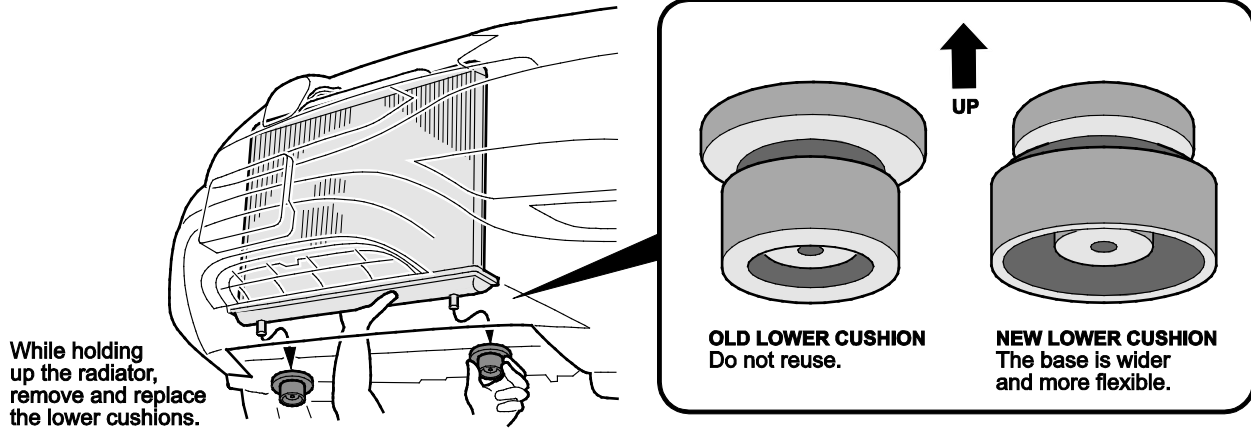
8. Replace both lower mounting cushions.

NOTE: Make sure to install them correctly as shown.

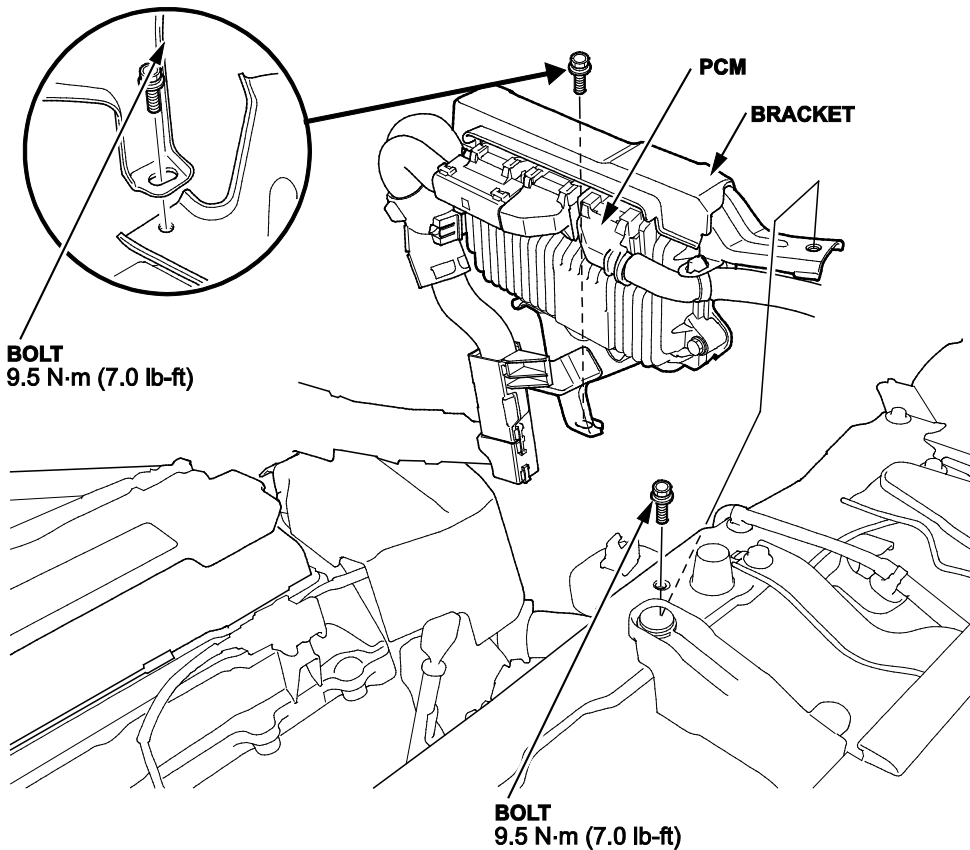
11. Move the PCM with bracket.

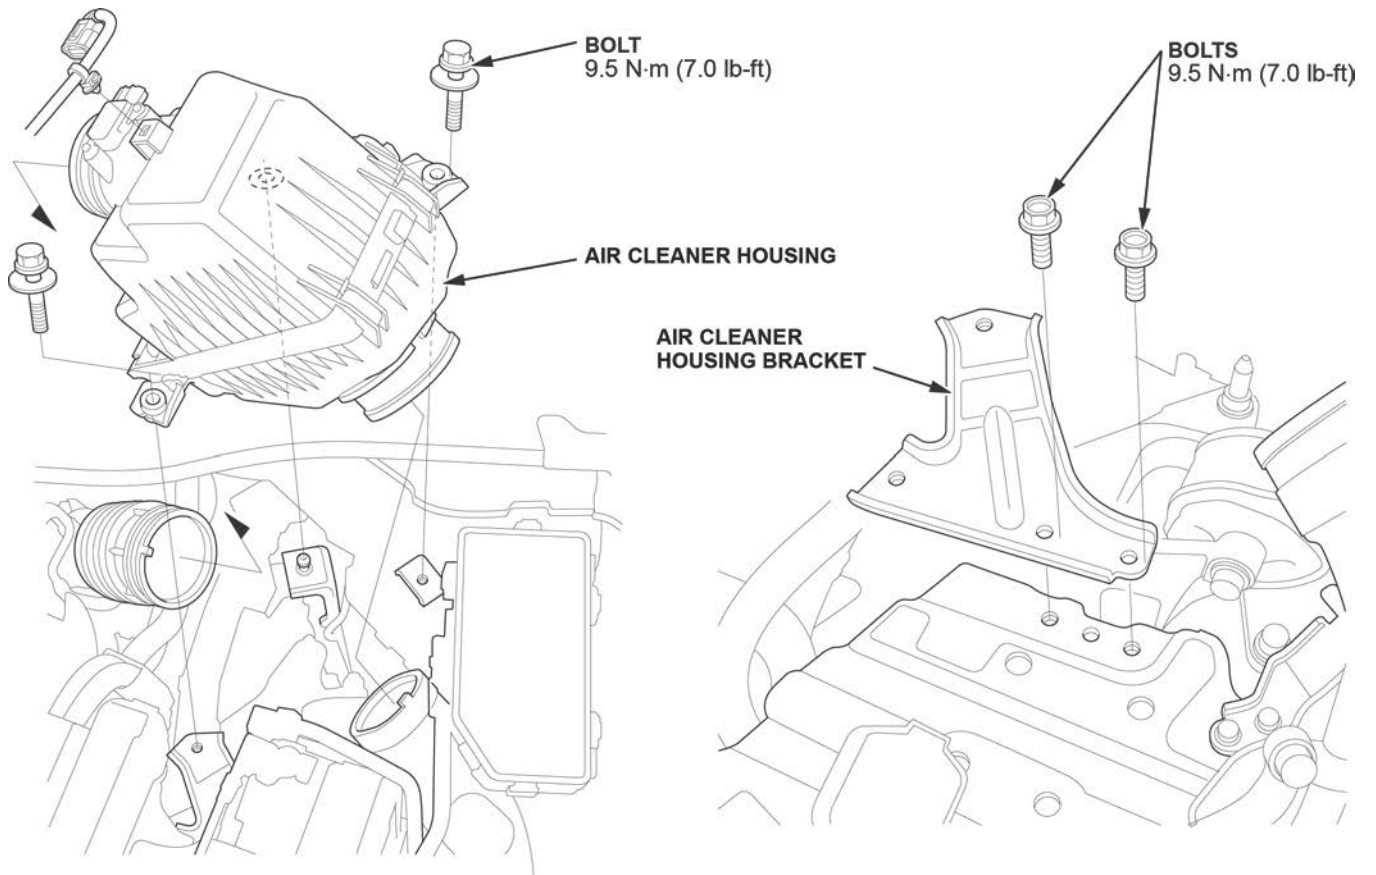
12. Remove the air cleaner housing and the housing bracket.

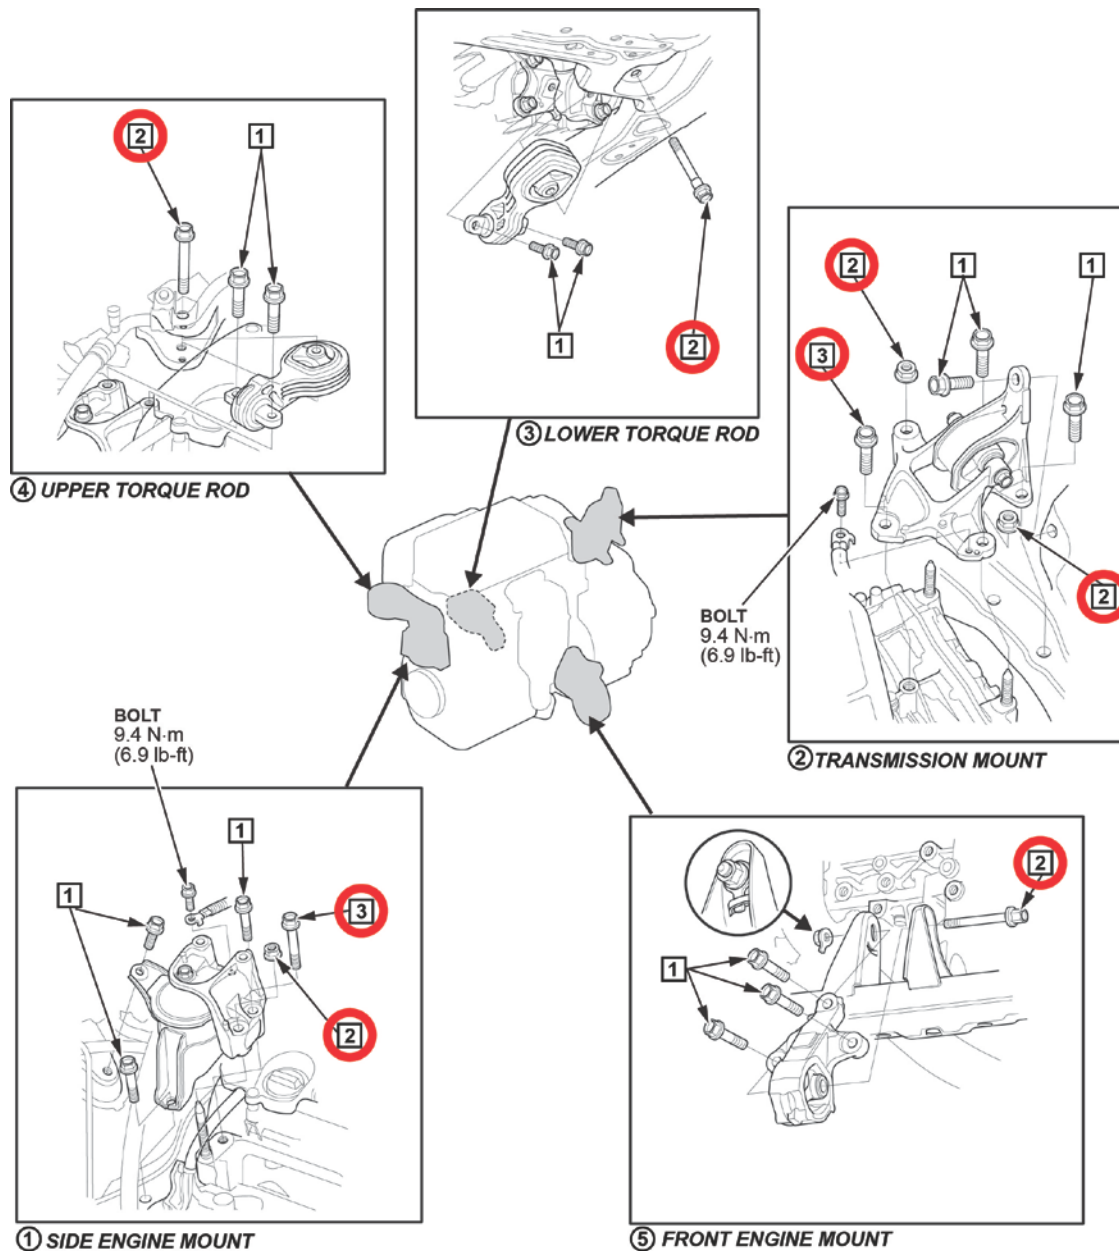
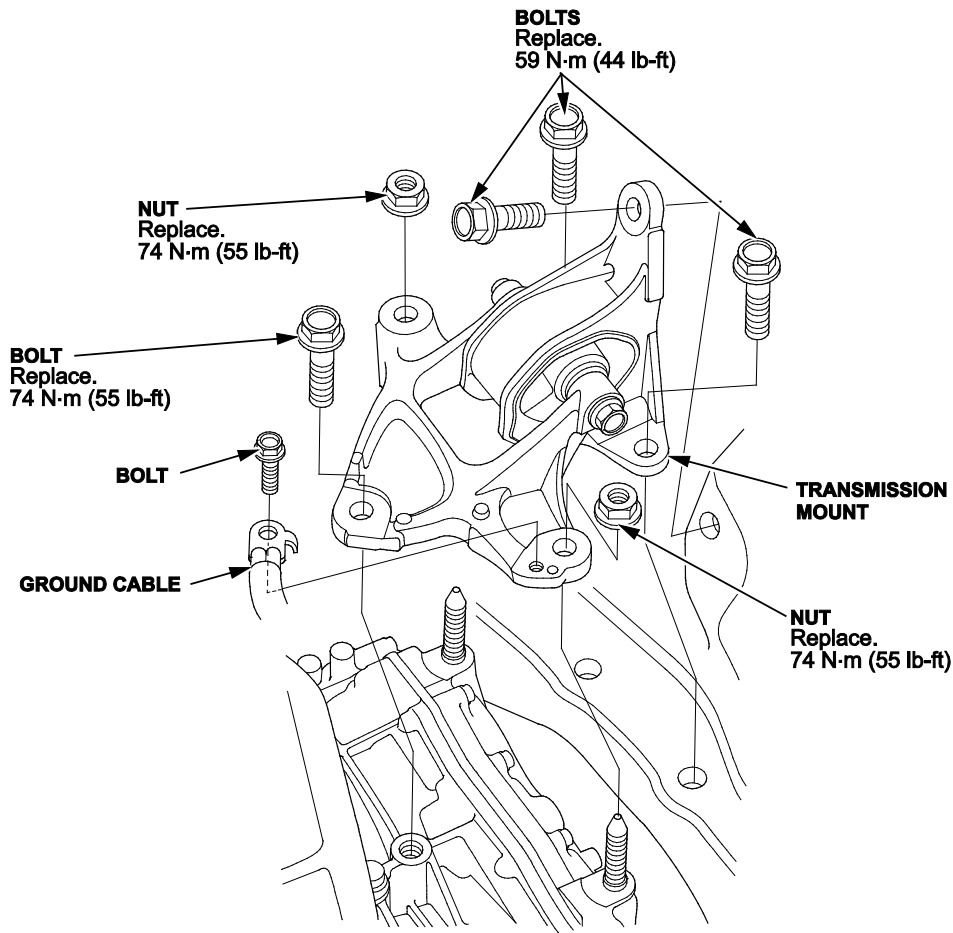
- Install the transmission mount leaving the highlighted bolts slightly loose.
- Loosen all highlighted bolts on the specific mounts.
- Then tighten all bolts and nuts in the sequence as shown below.

Mount Removed	Mount Tightening Sequence
Side Engine Mount and Transmission	1, 2, 3, 4, and 5
Lower Torque Rod	3
Upper Torque Rod	4
Front Engine Mount	5

Mount No.	Mount Name	Mount Bolt/Nut Tightening Sequence		
		1	2	3
1	Side Engine Mount	64 N·m (6.5 kgf·m, 47 lb-ft)	74 N·m (7.5 kgf·m, 55 lb-ft)	74 N·m (7.5 kgf·m, 55 lb-ft)
2	Transmission Mount	59 N·m (6.0 kgf·m, 44 lb-ft) Replace.	74 N·m (7.5 kgf·m, 55 lb-ft) Replace.	74 N·m (7.5 kgf·m, 55 lb-ft) Replace.
3	Lower Torque Rod	88 N·m (9.0 kgf·m, 65 lb-ft)	93 N·m (9.5 kgf·m, 69 lb-ft)	
4	Upper Torque Rod	74 N·m (7.5 kgf·m, 55 lb-ft)	54 N·m (5.5 kgf·m, 40 lb-ft)	
5	Front Engine Mount	74 N·m (7.5 kgf·m, 55 lb-ft)	64 N·m (6.5 kgf·m, 47 lb-ft)

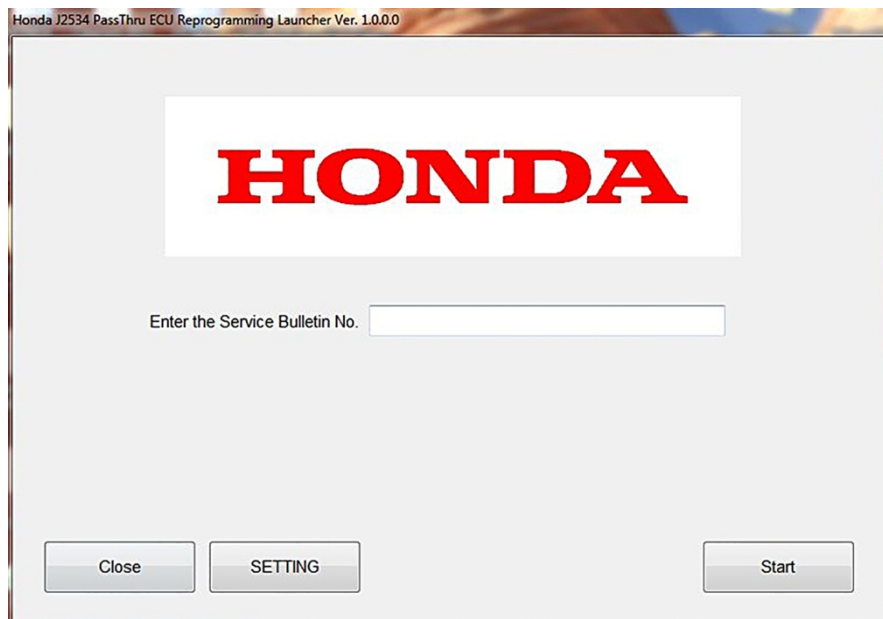
3. Enter the service bulletin number, then select **Start**.

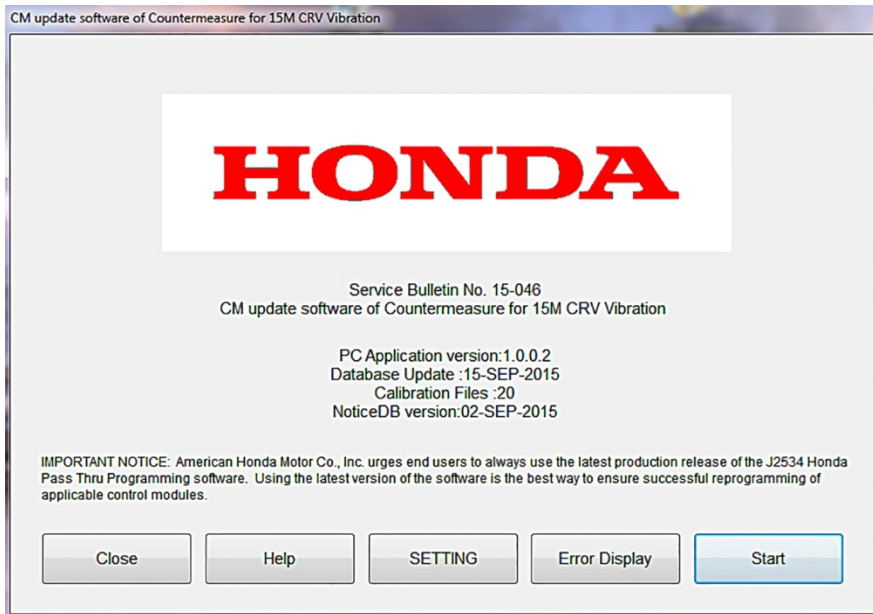
4. Make sure the information on the screen is correct, then click **Start**.

PC application Version 1.0.0.2
Database Update 15-SEP-2015
Calibration Files: 20
NoticeDB version 02-SEP-2015

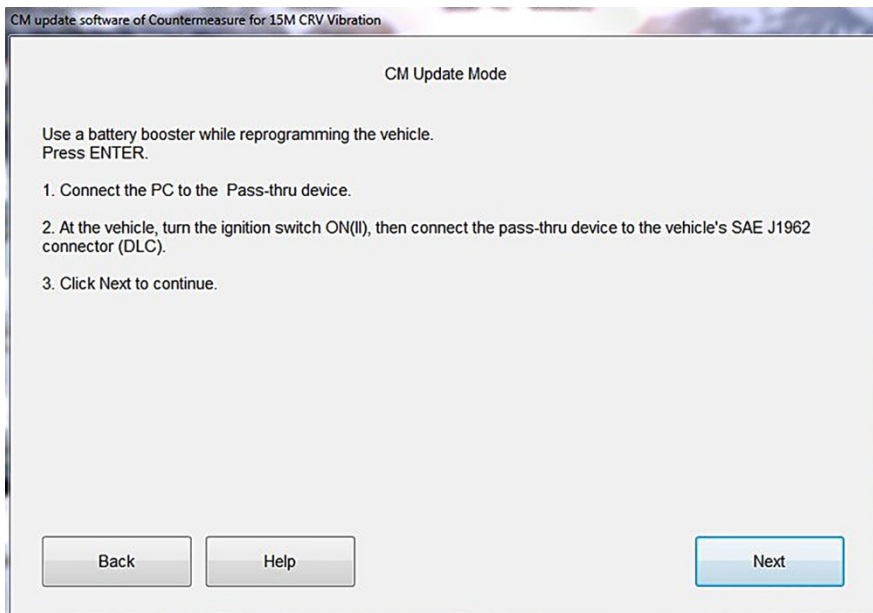
5. Make sure to follow the instructions on the screen to do the update, then click **Next**.

- Connect the PC to the MongoosePro Honda.
- At the vehicle, turn the ignition to ON, then connect the MongoosePro Honda to the vehicle's DLC.
- Click **Next** to continue.

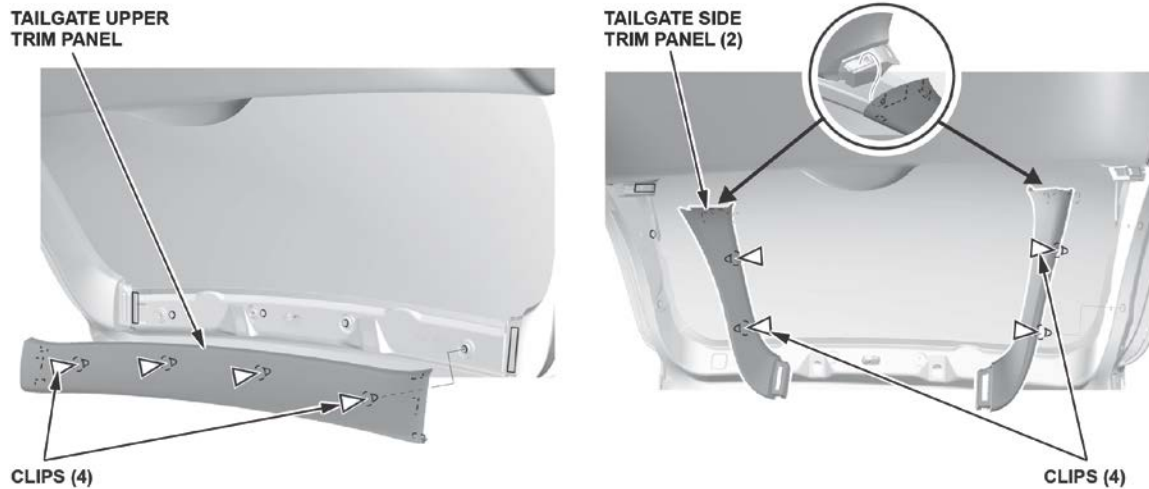
1. Remove the tailgate upper and side trim panels.

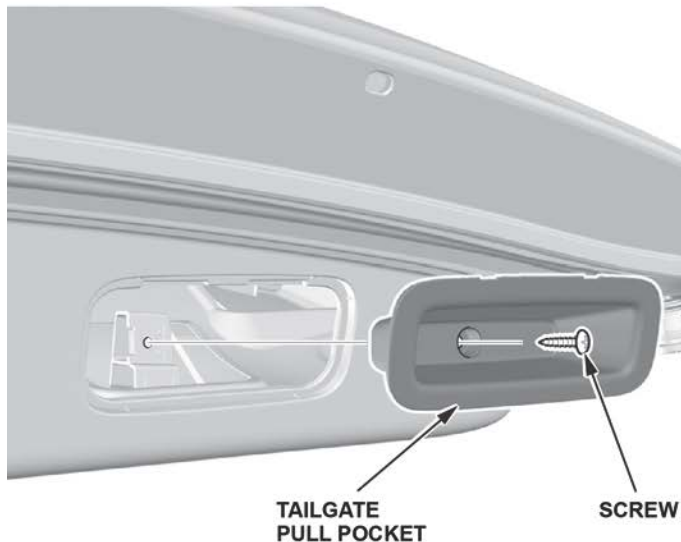
WITHOUT POWER TAILGATE

2. Remove the tailgate pull pocket.

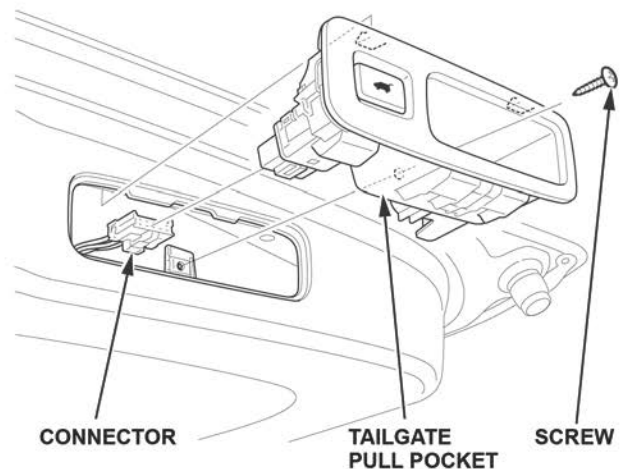
WITH POWER TAILGATE

- Make sure to disconnect the connector on power tailgate-equipped vehicles.
- Be sure to use a trim removal tool to avoid damage.

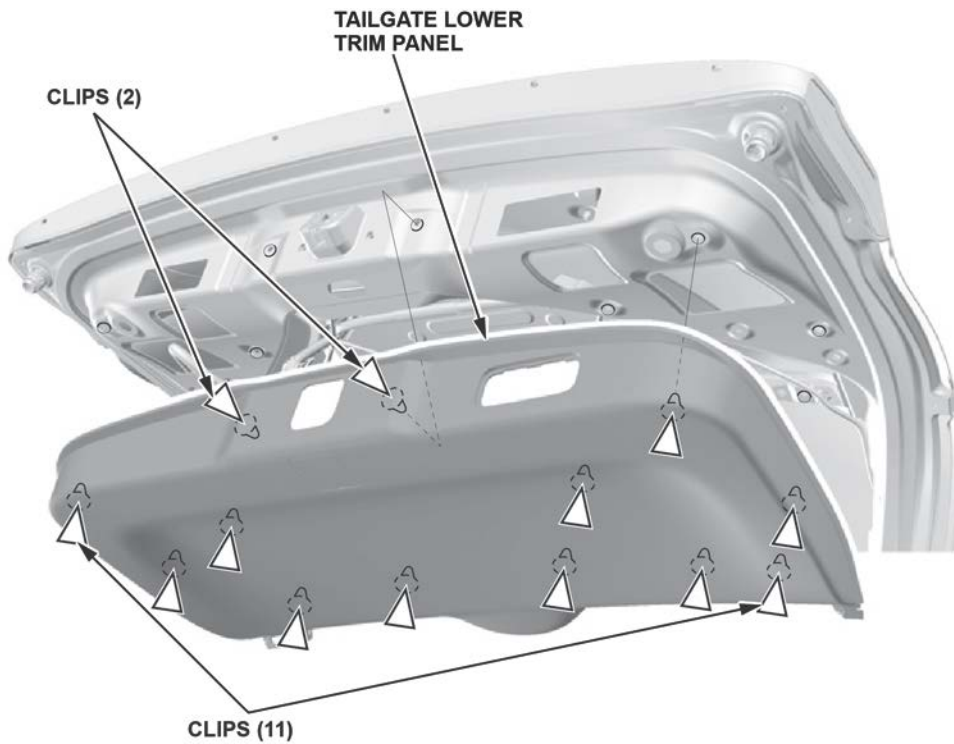
3. Remove the tailgate lower trim panel.

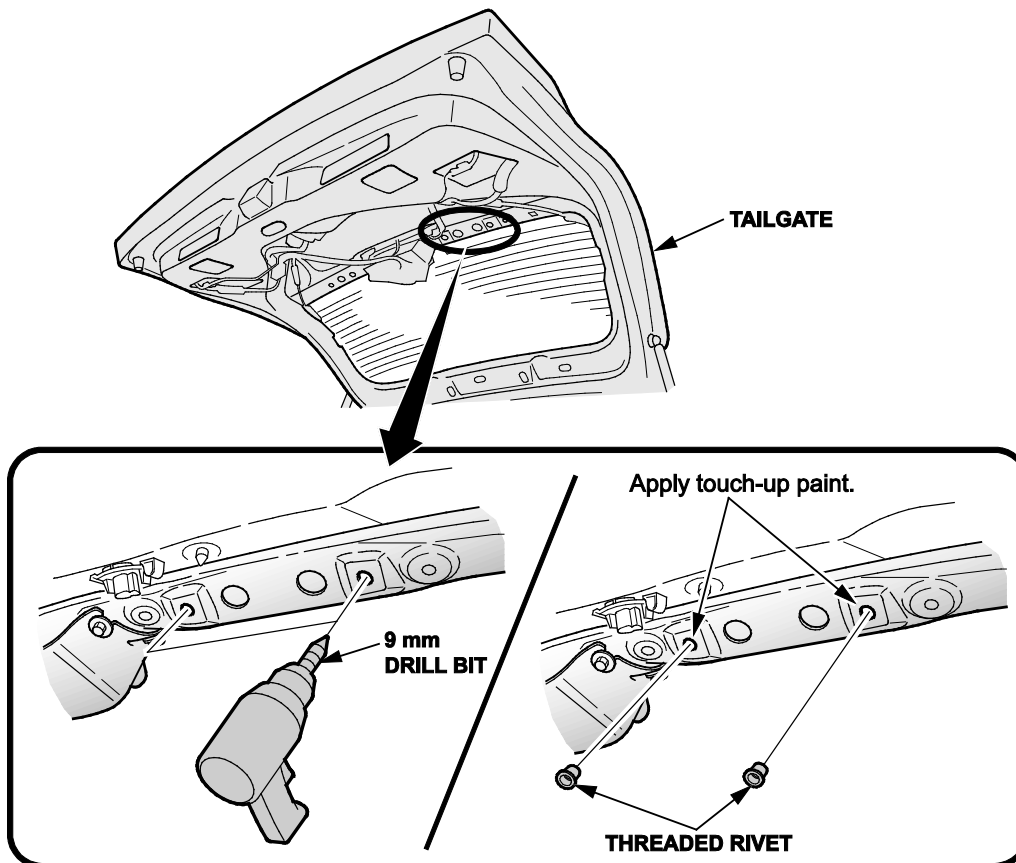
4. Enlarge the two mounting holes for the dynamic damper by drilling the hole from 7 mm to 9 mm. Remove any burrs.

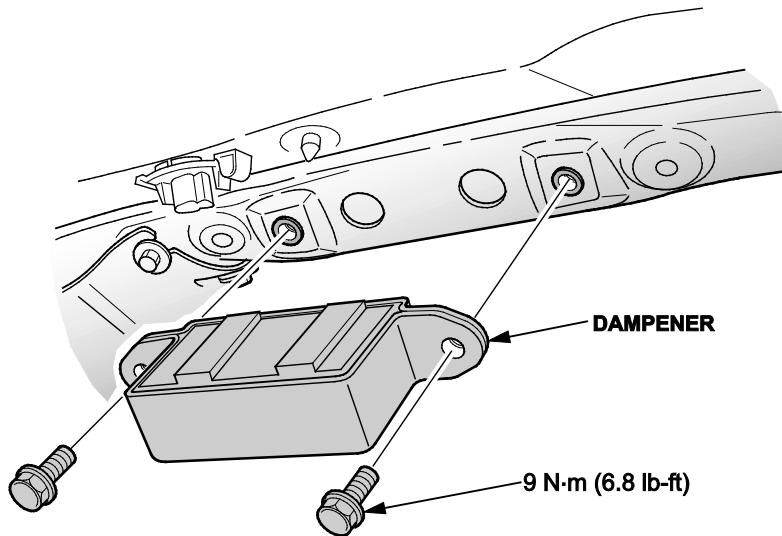
5. Cover any exposed metal with touchup paint and allow it to dry.
6. Install two threaded rivets in the recently drilled holes (using special tool 07AAZ-000A125).
7. Install the damper on the tailgate and torque the bolts to **9 N·m (6.8 lb-ft)**.

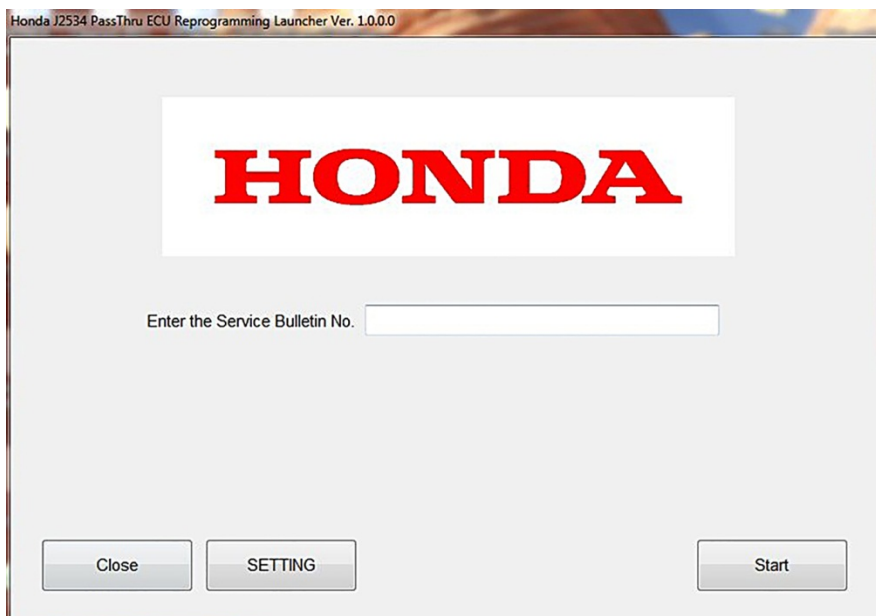
2. Enter the service bulletin number, then select **Start**.

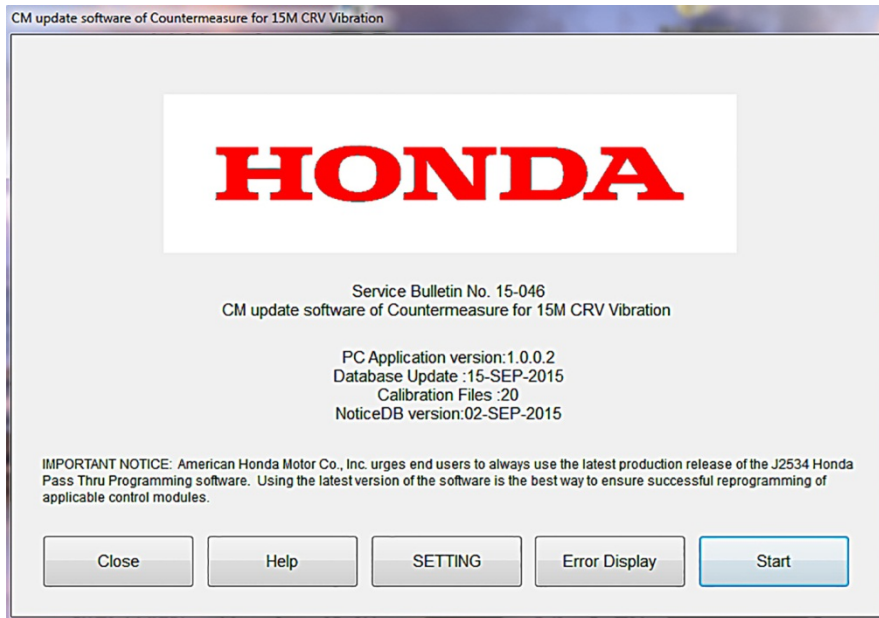
3. Make sure the information on the screen is correct, then click **Start**.

PC application Version 1.0.0.2
Database Update 15-SEP-2015
Calibration Files: 20
NoticeDB version 02-SEP-2015
